# COMBUSTION TURBINE (CT) HOT SECTION COATING LIFE MANAGEMENT

## *Semi Annual Technical Progress Report*

***Agreement Number:*** DE-FC26-01NT41231

R. Viswanathan/D. Gandy  
EPRI

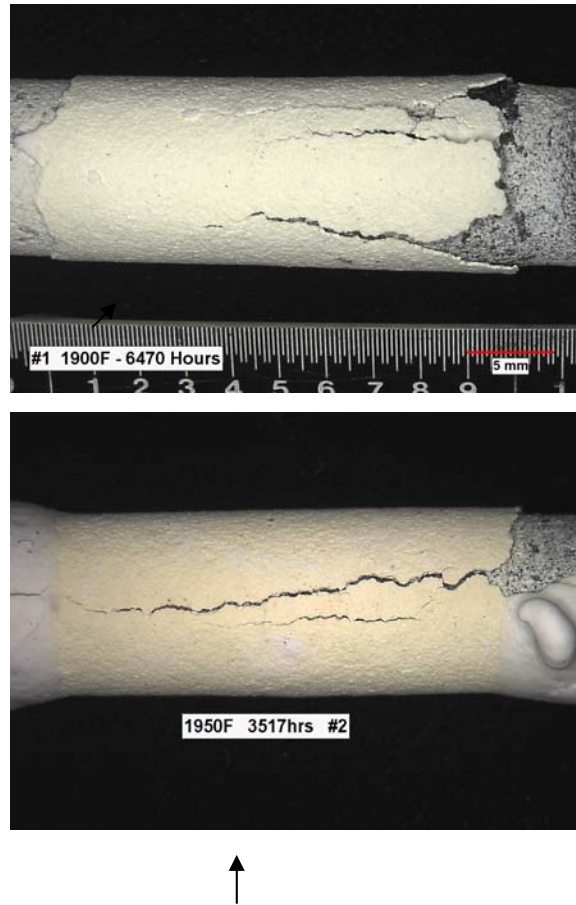
Isothermal Exposure Testing of the TBC coated specimens at 1066°C (1950°F), 1038°C (1900°F) and 1010°C (1850°F) was completed. Time to crack TBC for different coating/substrate systems is given in Table 5.4. The results show that under isothermal conditions, the TBC on platinum plated MCrAlY coated specimens exhibited slightly longer life. Typical morphology of cracking or spallation of the TBC on the specimens exposed at 1038°C (1900°F) and 1010°C (1850°F) is illustrated in Figures 5.1 and 5.2

**Figure 5.1: Condition of the coated specimens after exposure at 1038°C (1900°F) Arrows point to cracks.**

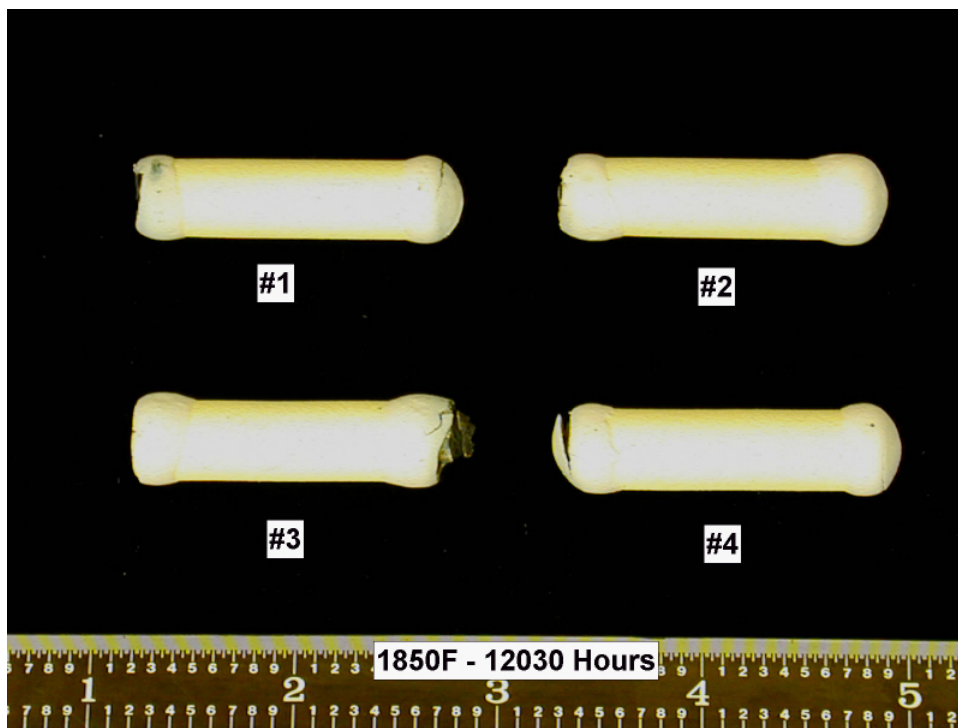
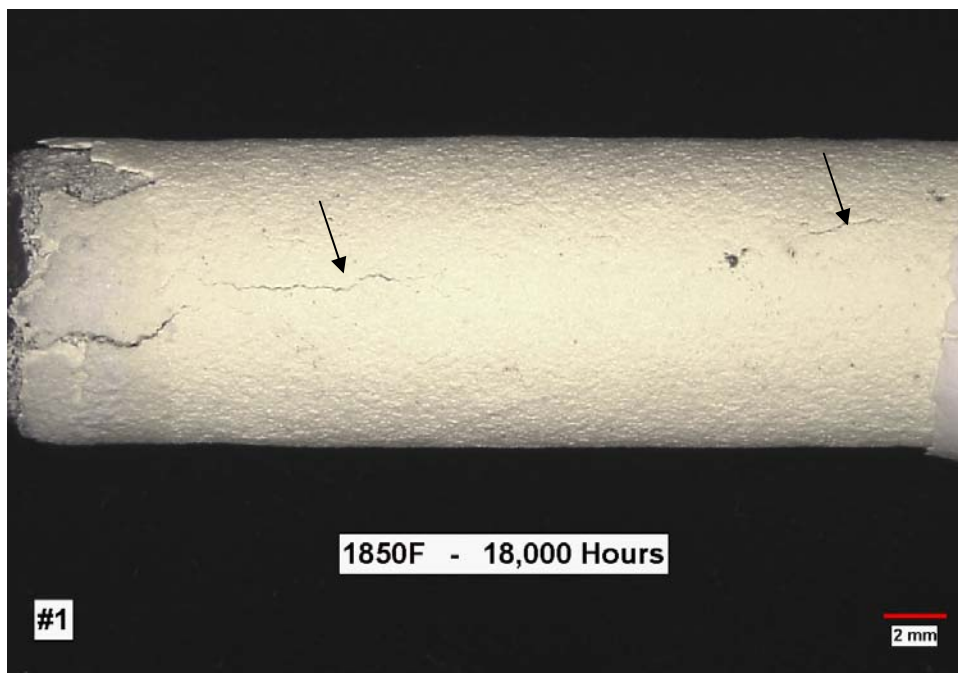
Figure 5.2: Photographs of TBC coated specimens after 12,030 and 18000 hours exposure at 1010°C (1850°F). Cracks were seen after 18,000 hours exposure. Arrows point to typical cracks

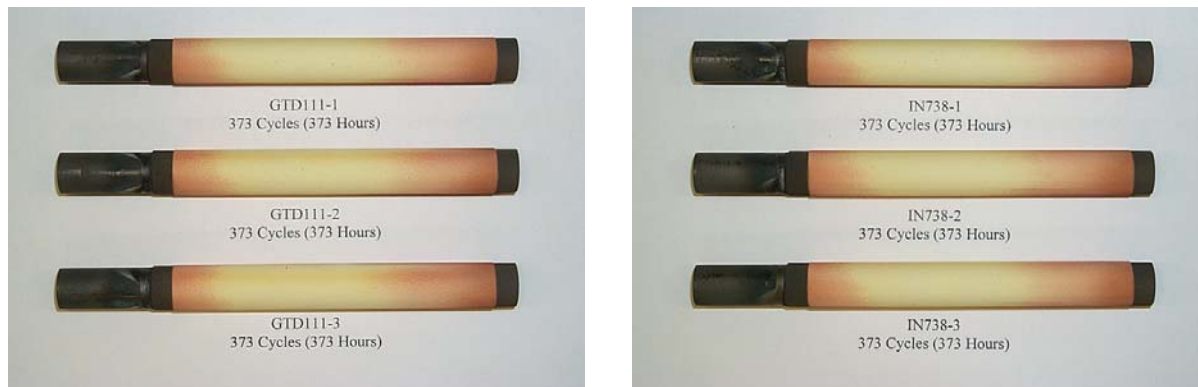
**Figure 5.3: Condition of the burner-rig test specimens after 373 one-hour thermal cycling at the peak temperature of 1950°F (1066°C)**

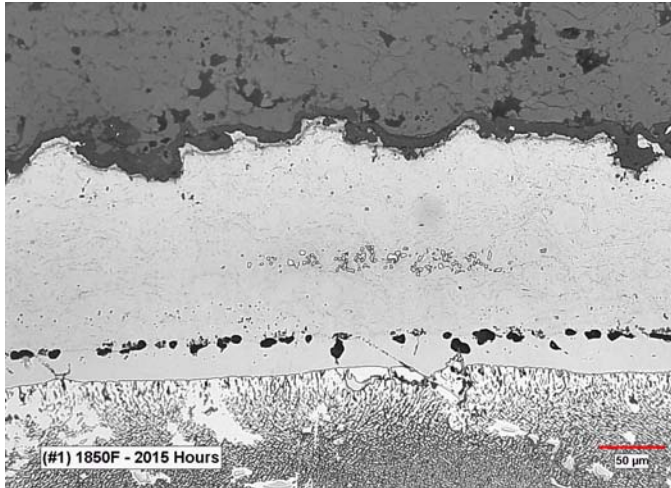
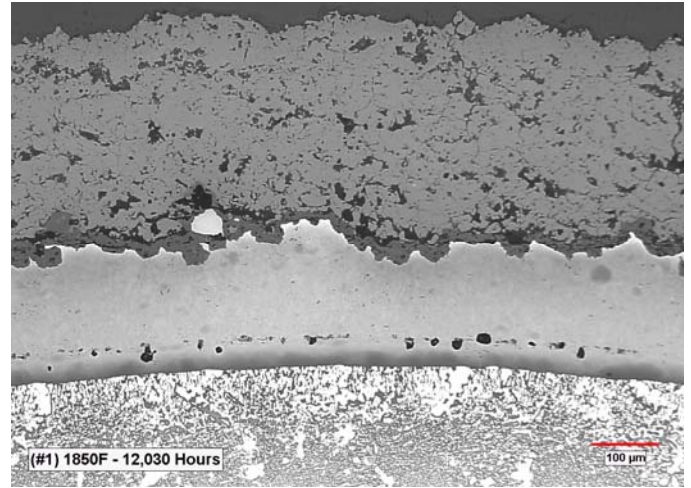
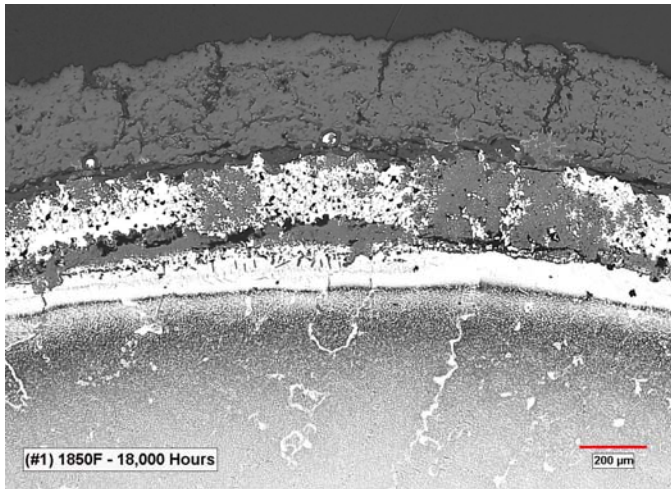
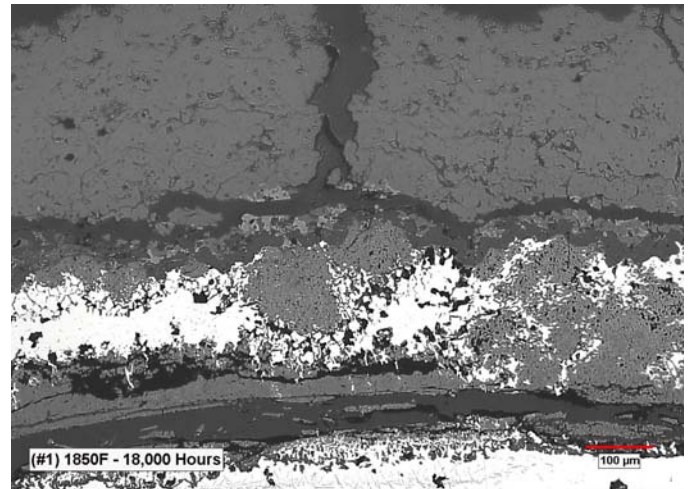
Metallurgical examination of the samples exposed at 1010°C (1850°F) showed that the  $\beta$ -phase in the bond coating on all systems was consumed in relatively short time (in about 2000 hours of exposure). Typical microstructure of the CoNiCrAlY coating on the GTD 111 specimens is shown in Figure 5.4 as a function of exposure time. The bond coating up to 12000 hours exposure showed no evidence of oxidation. The bond coating was severely oxidized after 18000 hours exposure. In isolated areas cracking due to delamination of the bond coating from the substrate was observed as shown in Figure 5. The oxidation and delamination of the bond coating led to TBC cracking in this sample. In other words, under isothermal conditions, after long-term exposure (similar to the operating conditions of a base loaded engine) the TBC failure mechanism may change from the TGO growth controlled mechanism to bond coating oxidation. The oxidation of the bond coating may also change the TBC failure location from the TGO/TBC interface to the bond coat/substrate interface. To understand the effects of bond coating and substrate alloy composition on the failure mode, the samples exposed for a long-time are being re-examined for internal oxidation and cracking.

**Figure 5.4: Optical microstructure of of CoNiCoCrAlY bond coating on the GTD 111 specimens. Note  $\beta$ -phase in the bond coating is completely consumed after 12030 hours exposure at 1010°C (1850°F), and bond coating was internally oxidized and delaminated after 18000 hours exposure. Internal oxidation of bond coating led to cracking**

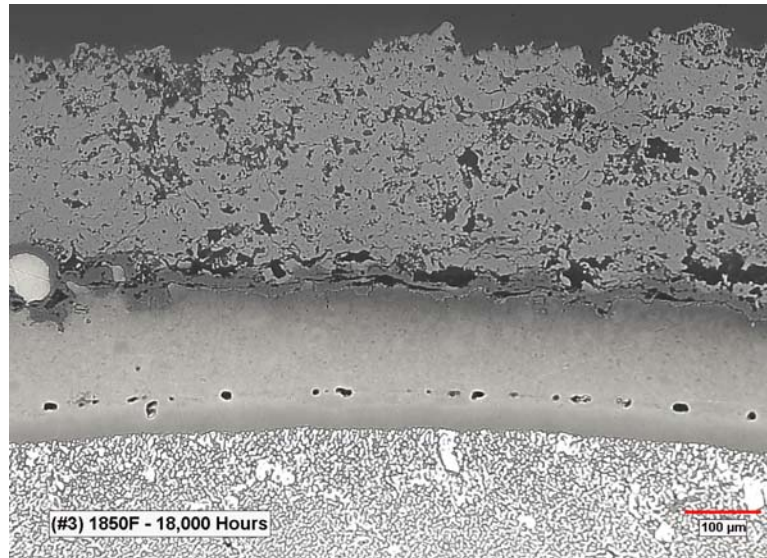
Figure 5.5 shows typical microstructure of the over platinum plated NiCoCrAlY coating on a GTD 111 specimen after 18000 hours exposure. In this case, no evidence of internal oxidation of the coating was observed. Metallurgical examinations revealed that the platinum plated inter layer was dissolved into the CoNiCrAlY bond coating. These observations imply that the presence of platinum improved the oxidation resistance of the CoNiCrAlY bond coating.

**Figure 5.5: Optical microstructure of CoNiCoCrAlY with a platinum layer between the bond coating and TBC on a GTD 111 specimen - Note that platinum interlayer dissolved in the CoNiCoCrAlY coating and the  $\beta$ -phase in the bond coating is completely consumed after 1800 hours exposure at 1010°C (1850°F), and no evidence of bond coating oxidation**

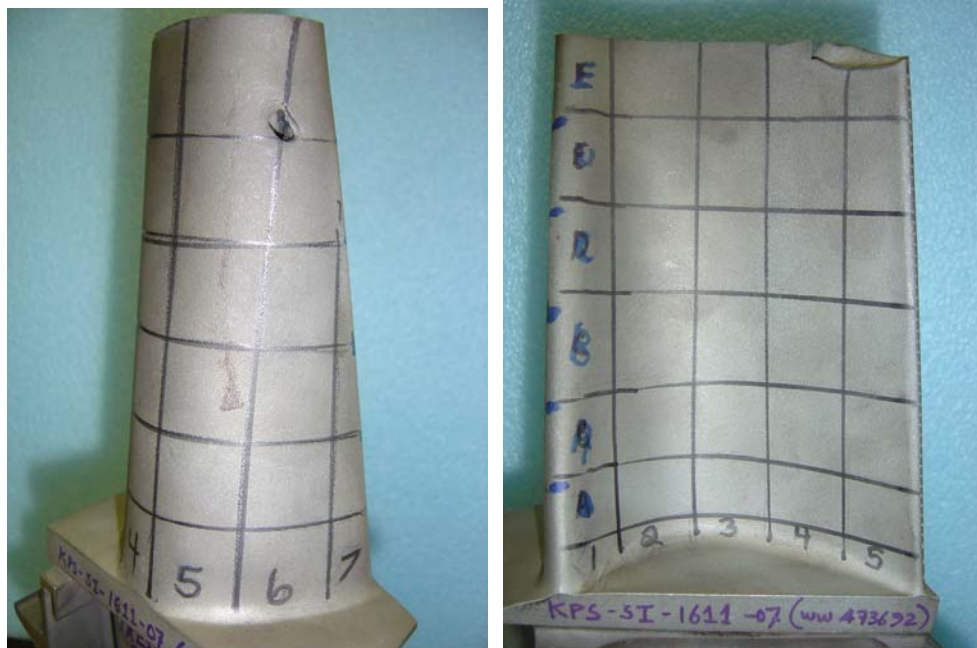
The aged bucket #7 from frame PG7231 logged 8,286 operating hours with 670 startups. As in other GT 33 coated buckets, it is topped with aluminide overlay coating. This bucket is made of directionally solidified GTD-111 base metal with GT 33+ duplex coatings. Figure 6.4 shows the bucket from the suction and pressure sides with outlined grids. There was foreign object damage to the bucket as shown on the suction side.

**Figure 6.4: Grid outlines of Bucket #7 showing damaged suction side and pressure side with GT 33+ duplex coatings**

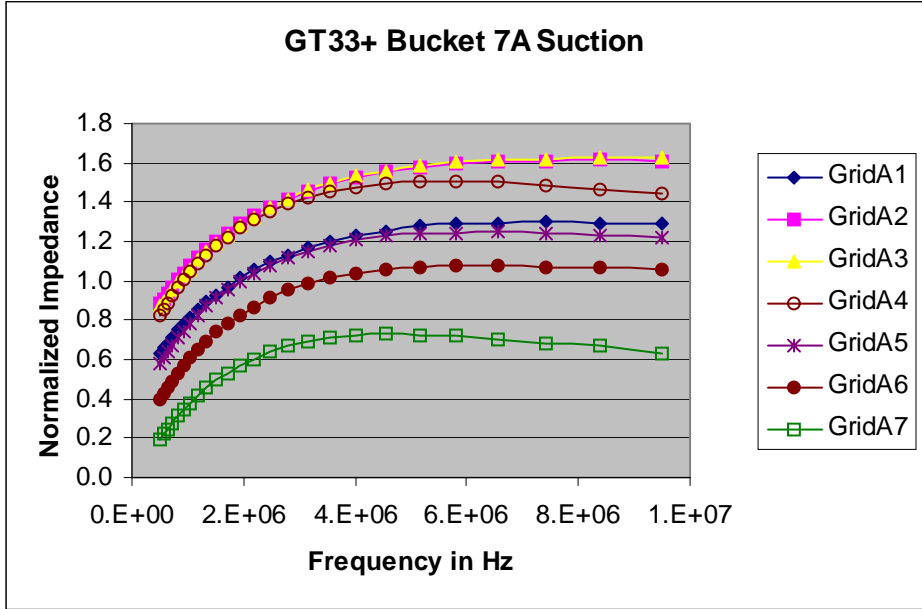
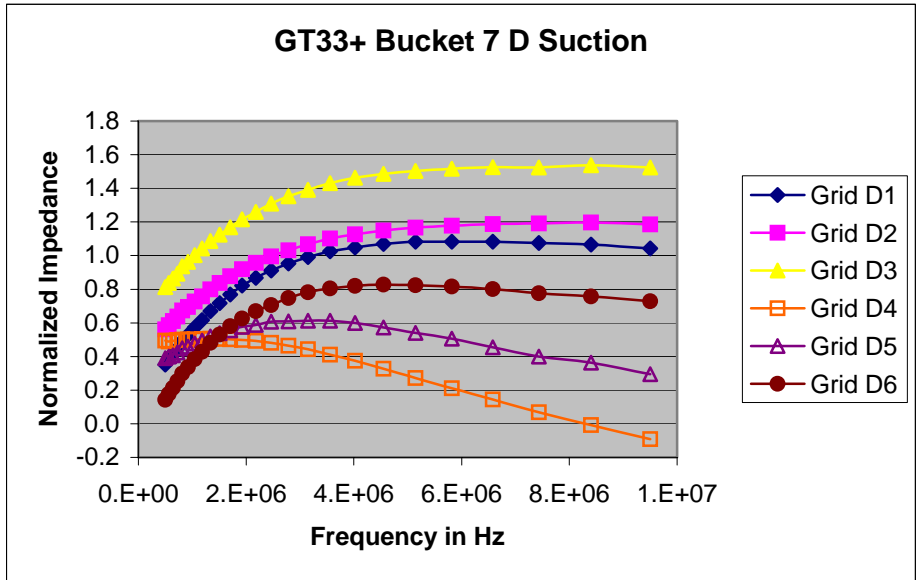
**Figure 6.5: Comparison of normalized impedance values from 7A and 7D sections where normal coating conditions were observed closer to the platform.**

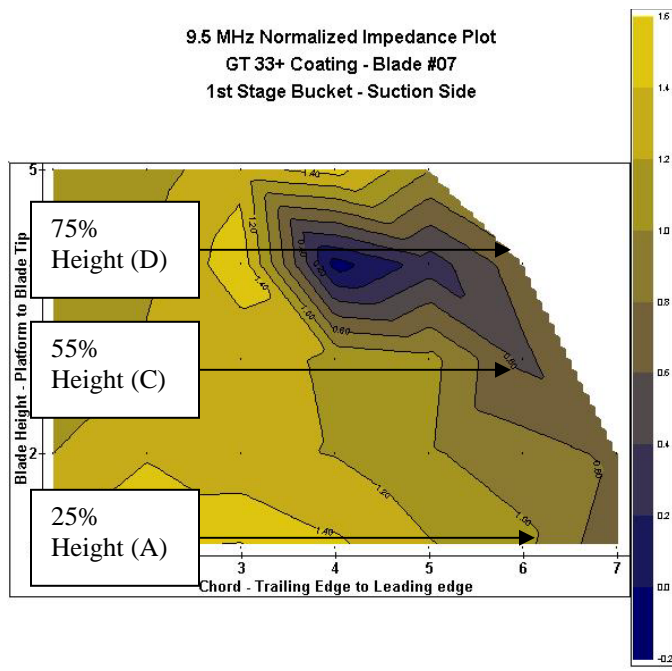
Figure 6.6 shows color-coded surface plots of normalized impedance values showing three selected bucket height areas for destructive sectioning: 7A, 7C, 7D. Dark areas represent degradation areas caused by the combined effect of thermal mechanical fatigue cracking and beta-phase depletion.

**Figure 6.6: Normalized impedance plots of bucket #7 showing sectioned areas, A, C, and D, with damaged area at about 75% of the bucket height on the leading edge side**

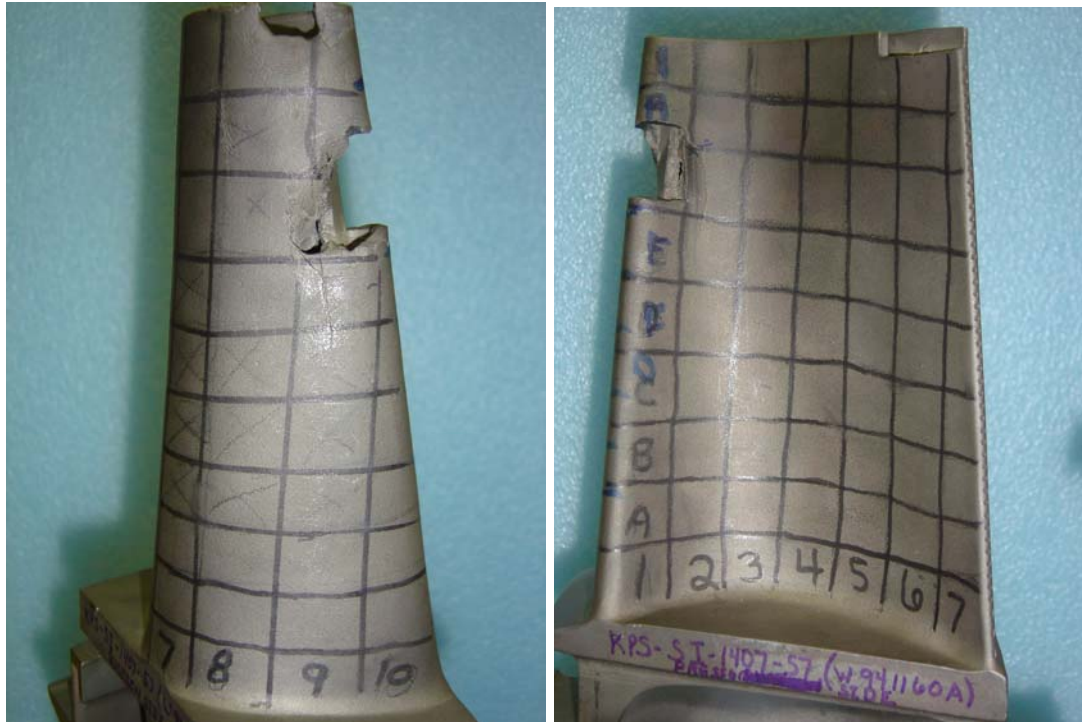
Figure 6.7 shows the bucket from the suction and pressure sides with the outlined grid patterns. The obvious foreign object damages are shown in the picture.

**Figure 6.7: Bucket #57 with GT 33+ duplex coatings showing grid patterns and damaged suction and pressure sides**

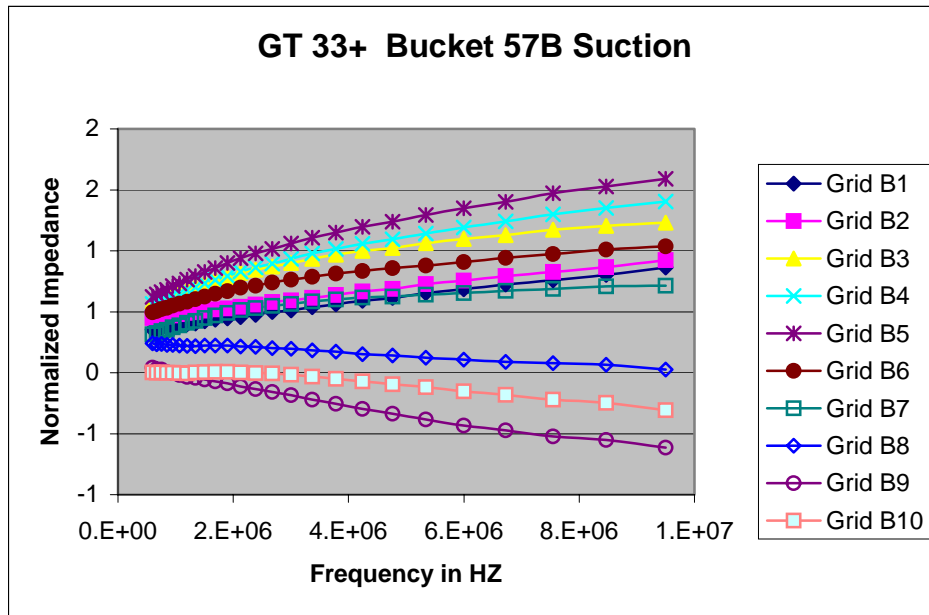
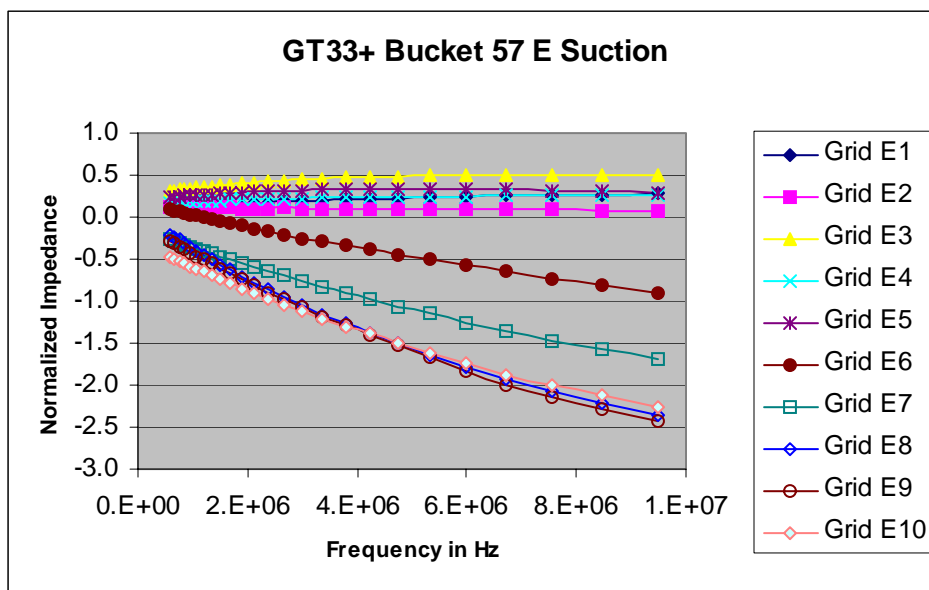
Figure 6.8 shows newly acquired data set of normalized impedance values in the range of 0.6 –9.5 MHz. Two areas from the suction side, 57B and 57E, were selected for additional characterization by destructive tests. 57B measurements were taken at approximately 1 3/8 inches from the platform, while 57E measurements were taken at approximately 3 1/2 inches from the platform. From the suction side, Grids B1 and E1 are found on the trailing edge while Grids B10 and E10 are found on the leading edge. On the pressure side, just the opposites are true – Grids B1 and E1 are on the leading edge, while B10 and E10 are on the trailing edge.

**Figure 6.8: Comparison of normalized impedance values from 57B and 57E sections where beta-phase depletion and possible cracking are noted at 50 percent of the bucket height**

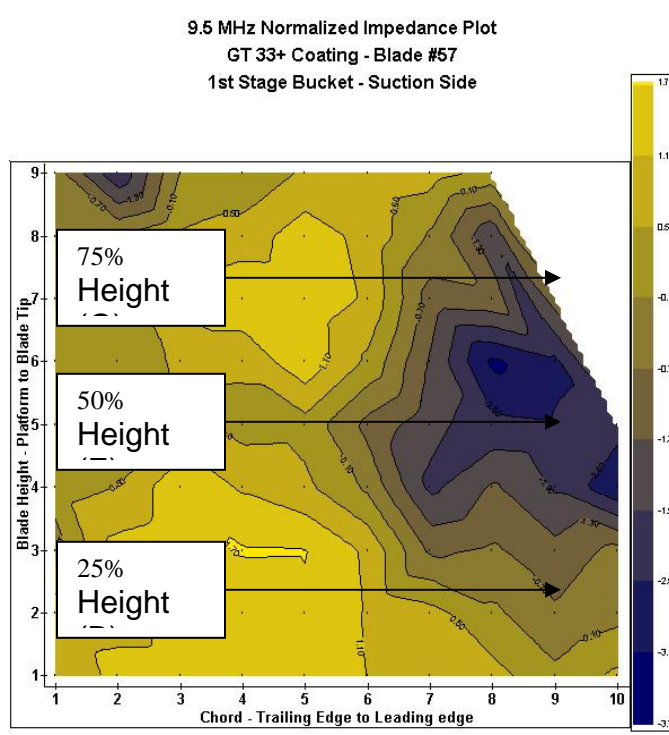
**Figure 6.9: Normalized impedance plots of bucket #57 showing sectioned areas, B, E, and G, with damaged areas extending from about 25% to 75% of the bucket height on the leading edge side**

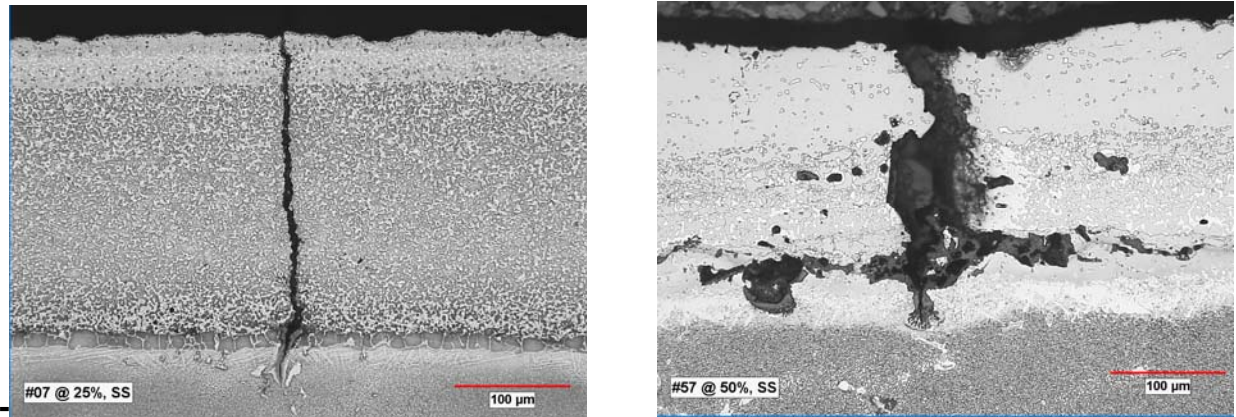
Examinations of the mounts showed that these buckets had over aluminized NiCoCrAlY coating (GT 33 +). Thermal-mechanical fatigue (TMF) cracks were observed on the convex side of the airfoil near the leading edge of Bucket 7. Majority of the cracks in this bucket were shallow and only a crack in the bucket had extended into the substrate. The deepest crack in Bucket 7 was located on the suction side of the airfoil near the leading edge at the 25% height. Bucket 57 was more severely cracked than Bucket 7. On Bucket 57, TMF cracks were observed on both the convex (suction) and concave (pressure) sides of the airfoil. Several cracks in Bucket 57 were extended into the substrate. Typical morphology of TMF cracks is shown in Figure 7.2.

**Figure 7.2: Optical Micrographs of sections of Buckets 7 and 57 Showing TMF Cracks**

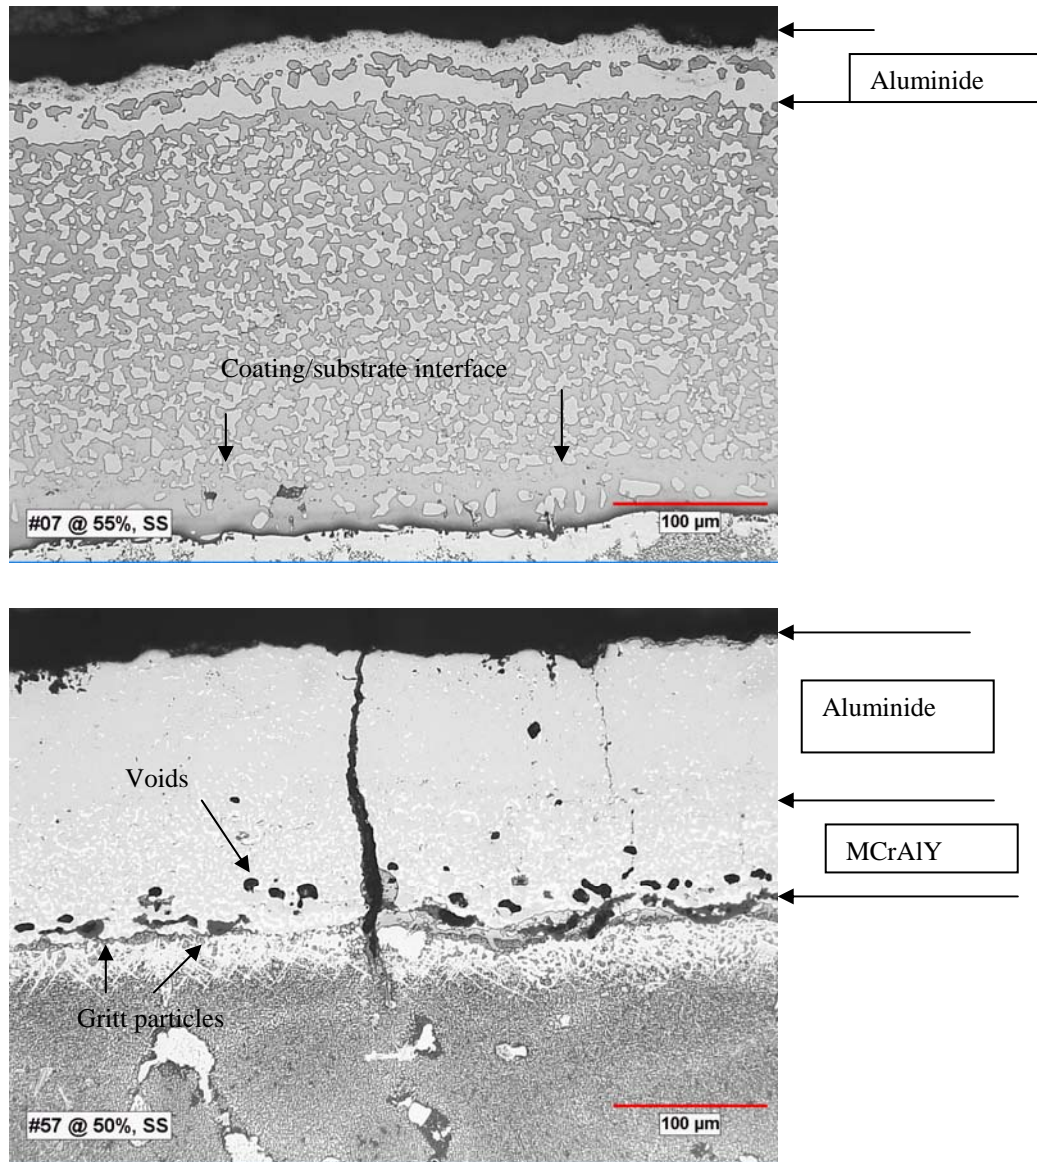
The quality of the coating on Bucket 57 was poor. The thickness of the MCrAlY and aluminide coatings on this bucket was not uniform. In addition, several grit particles were observed at the MCrAlY/substrate interface. In many areas TMF cracks propagated along the contaminated bond coat/substrate interface. Bucket 7 exhibited an uniform top aluminide (0.002 inch thick) layer both on the convex and concave sides of the airfoil. Variation of the quality of the coating on the two buckets is compared in Figure 7.3.

**Figure 7.3: Optical micrographs of coating on Bucket 57 and 7 showing variation of aluminide/MCrAlY thickness and the presence of grit particle at the coating/substrate interface.**

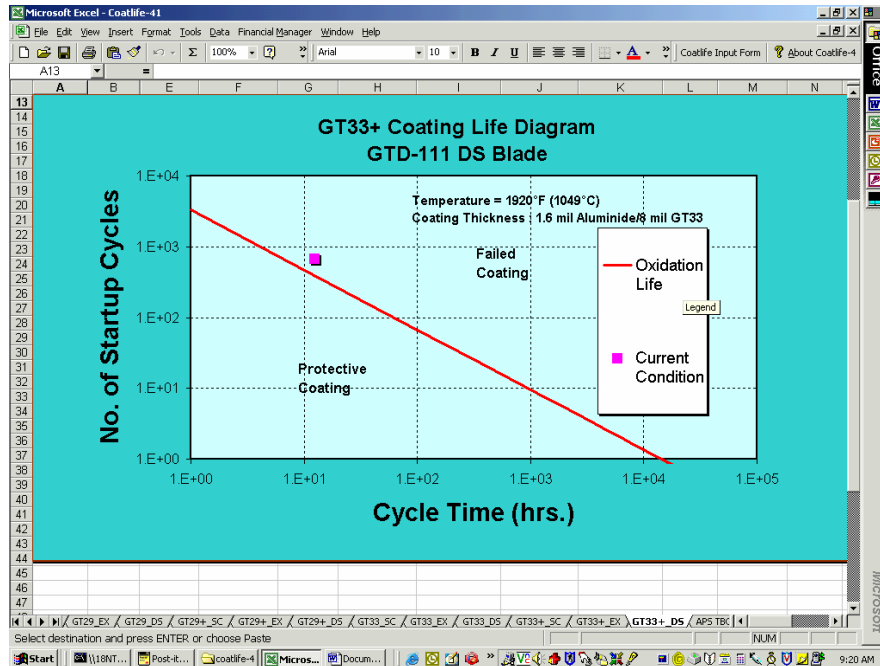
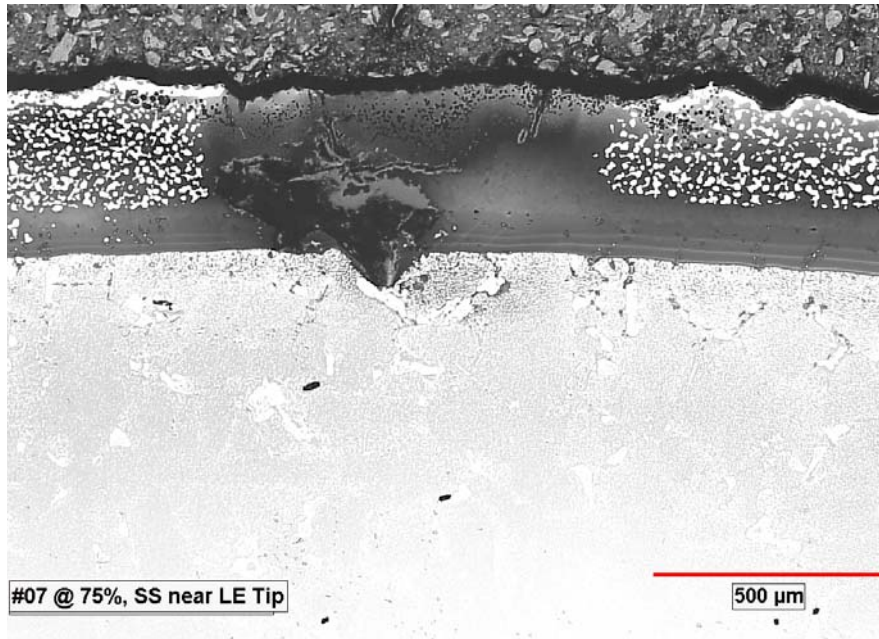
Bucket 7 experienced cracking at the leading edge but not at the trailing edge. Based on the interdiffusion zone width, the local temperature was determined to be 1920°F at the leading edge and 1785°F at the trailing edge. COATLIFE prediction indicates that the oxidation life has been totally consumed (170% life) at the leading edge, but only 47% life has been consumed at the trailing edge. A comparison of COATLIFE prediction and metallographic results of the coating at the leading edge are presented in Figures 7.4 (a) and (b), respectively. The corresponding comparison for results of the trailing edge are presented in Figure 7.5 (a) and (b), respectively. Similar predictions have been made on the other two 7FA machines, which had failure at Bucket C and Bucket 57. A summary of the COATLIFE prediction of oxidation life of CT33+ coating against field data is presented in Table 7.2.

**Figure 7.4: Comparison of COATLIFE prediction of oxidation life for GT33+ against field data for the leading edge (75% bucket height) of Bucket 7 in a 7FA machine after 8286 hours and 670 startups: (a) oxidation failure predicted by COATLIFE-4, and (b) metallographic section showing  $\beta$ -depleted coating at the leading edge tip of Bucket 7.**

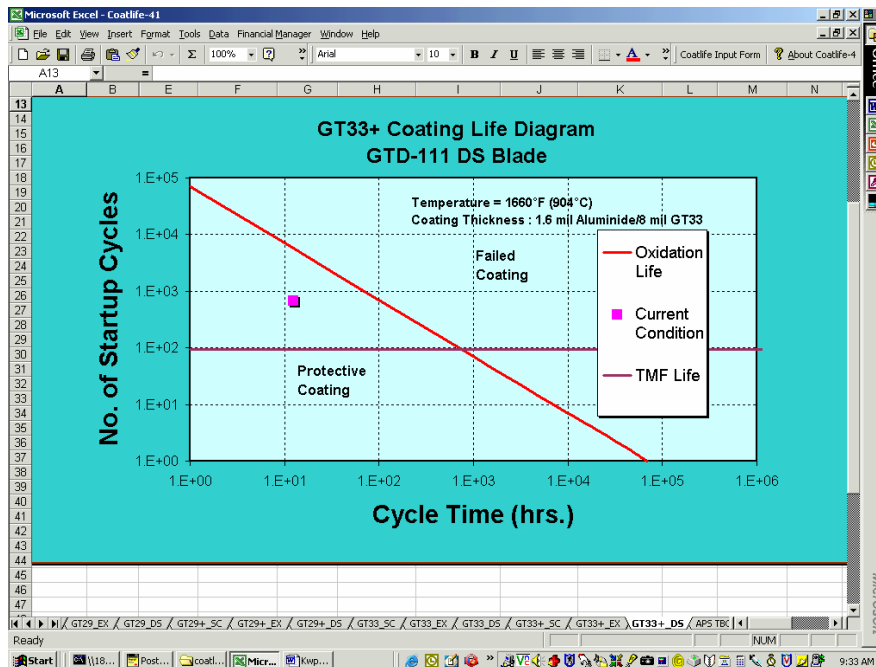
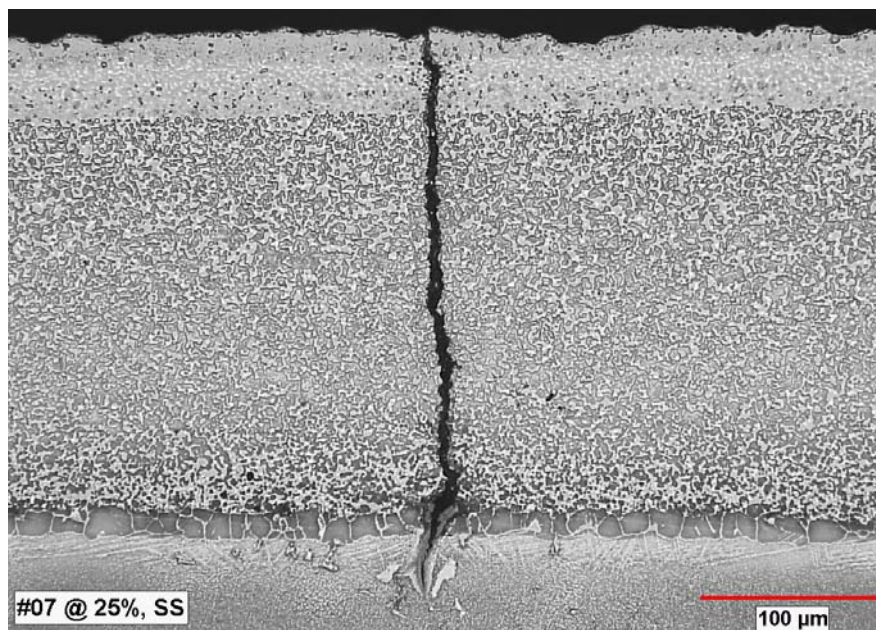
Buckets C, 7, and 57 with GT33+ coating also experienced TMF cracking at different airfoil heights. A summary of the operation history of these buckets is shown in Table 7.2. The local temperature and TMF strain ranges computed by TTI for these locations are also shown in Table 7.2. COATLIFE predictions indicate that the coatings are protective against oxidation, but have exceeded their TMF lives. Figure 7.6 (a) shows the coating life diagram for 7FA Bucket 7 at 25% bucket height. The local temperature was 1660°F and the TMF strain range was 0.8%. After 670 startups at 12.36 hours/cycle (8286 total operating hours), only 14.55% of the oxidation life had been consumed but the coating has exceeded the predicted TMF life (94 cycles) considerably. Metallographic examination of the bucket, Figure 7.6 (b), indicates that the TMF crack had penetrated into the base metal. Figure 7.7 (a) shows the coating life diagram for 7FA Bucket C at 55% bucket height. The local temperature was 1680°F and the TMF strain range was 0.65%. After 272 startups at 22.63 hours/cycle (6156 total operating hours), only 10.81% of the oxidation life had been consumed but the coating had exceeded the predicted TMF life (217.2 cycles). Metallographic examination of the bucket, Figure 7.7 (b), also indicates that the TMF crack had penetrated into the base metal and a small portion of the coating had spalled.

**Figure 7.6: Verification of COATLIFE prediction against field data of GT33+ coated GTD111 DS bucket:**  
(a) COATLIFE prediction of TMF failure at 25% BH of Bucket 7 in a 7FA machine, and (b) metallographic section showing TMF crack penetration into the substrate.
